The Brean Cross Link

Detailed proposals from the Sluices to Warren Road

Appendix One: Planning Submission

Location Plan for Warren Road and Brean Cross Sluice link path

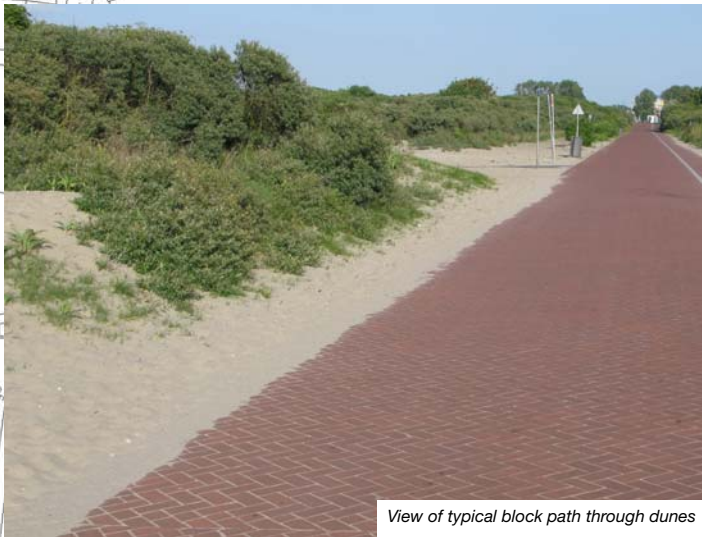
View of typical block path through dunes

Path continues to reach sea via existing brideway. Surface in interlocking brick blocks to give a firm surface which can be cleaned off by tractor, as this link is prone to drifting sand.

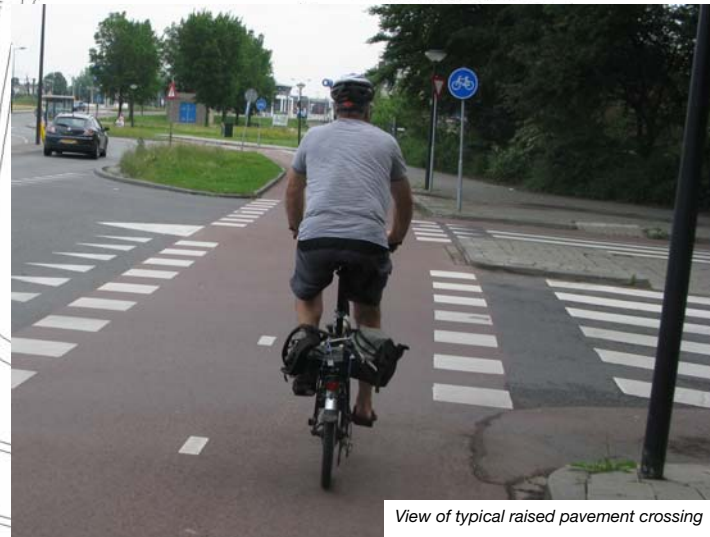
View of typical raised pavement crossing

A raised pavement crossing of Warren Road would be very helpful for local visitors wishing to reach the beach. Walkers to Brean Down will want to go this way.
